**ALBERTA HIGHWAY SERVICES LTD.  
STARS TECH ECO-ST TRIAL  
2023 WINTER OPERATION REPORT**

# INTRODUCTION

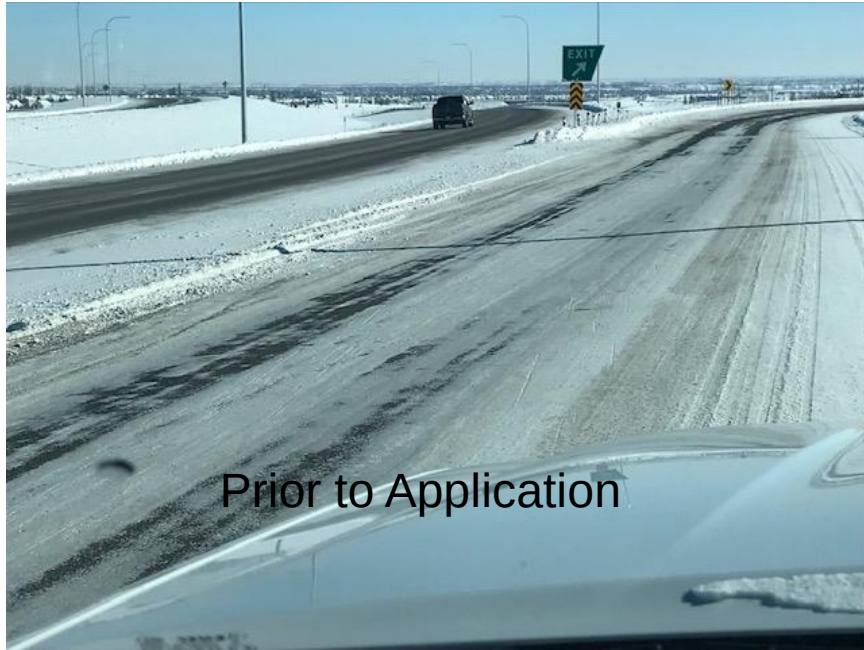
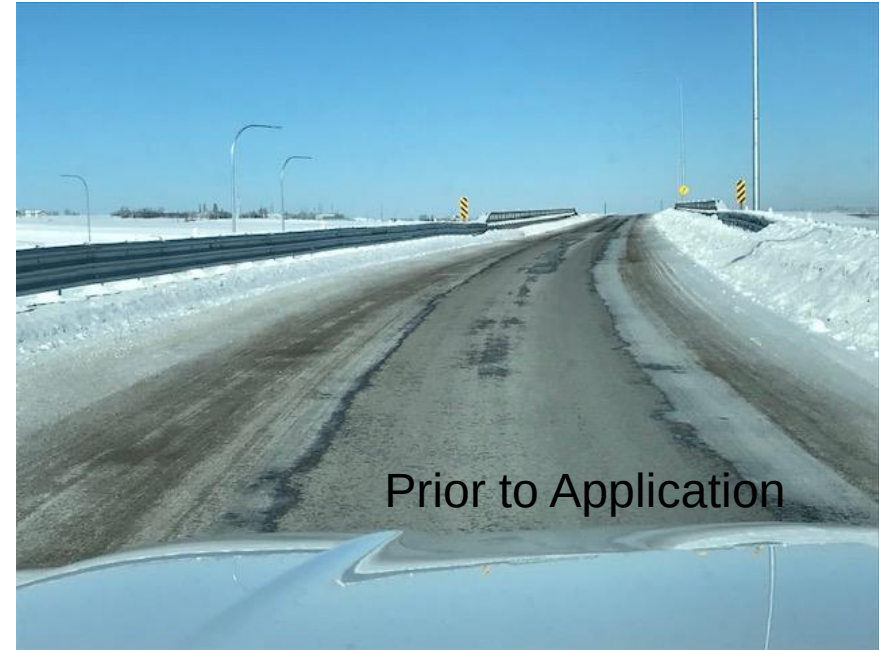
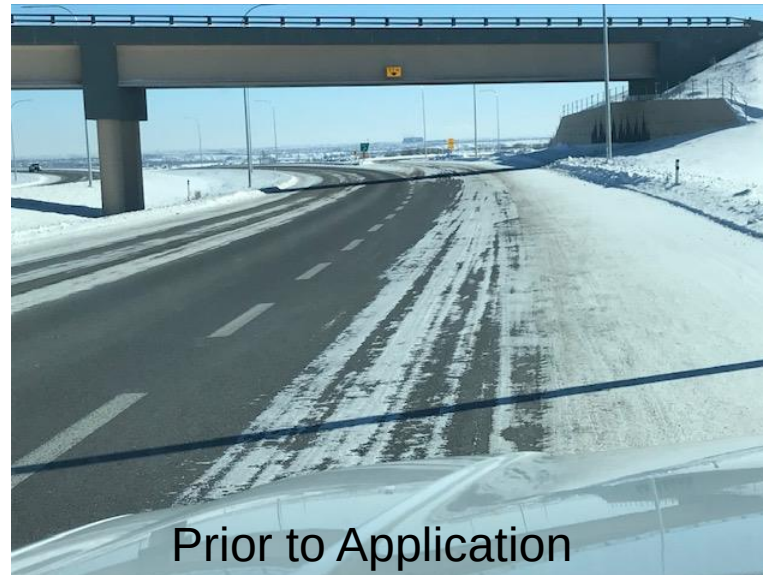
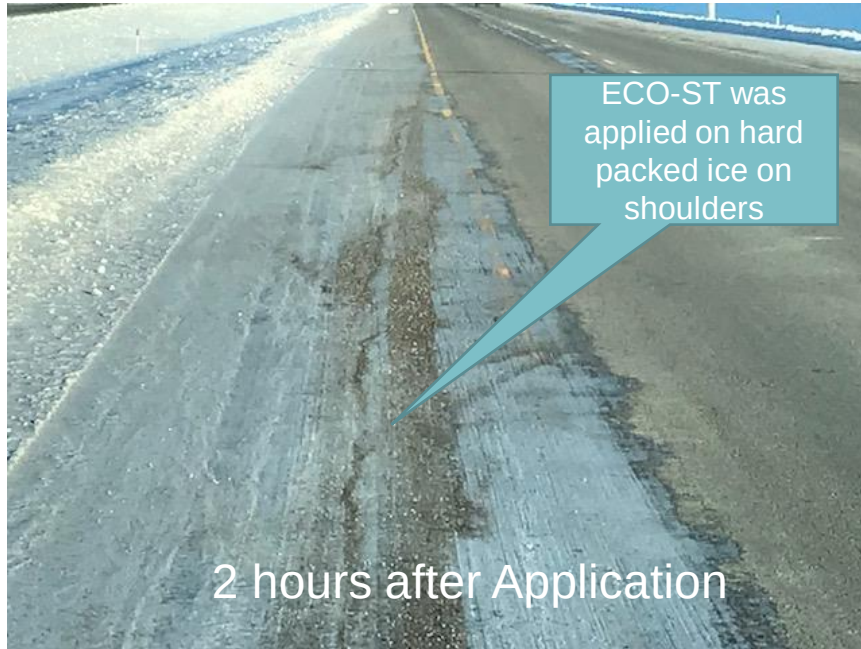
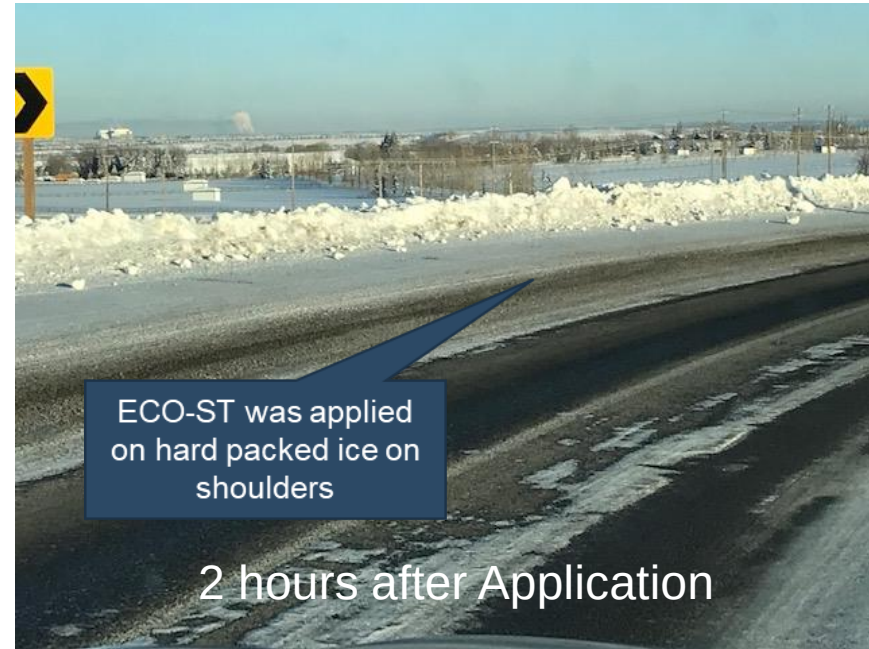
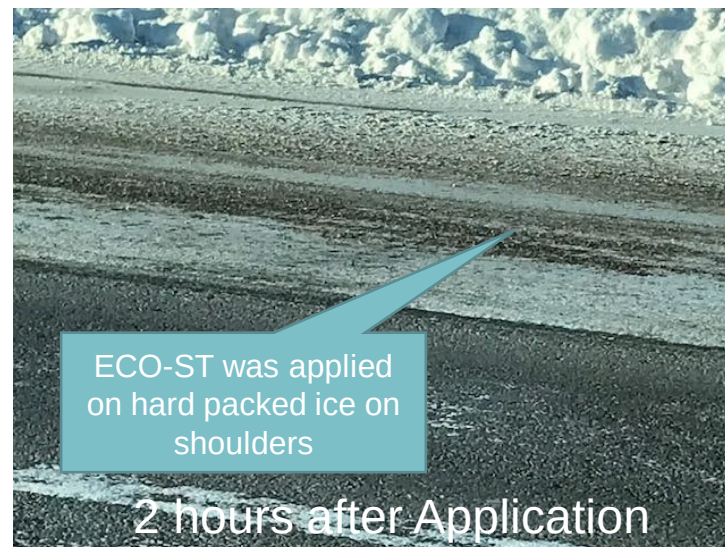
# FEBRUARY 24 SNOW EVENT

Surface Conditions at application: Hard Packed Snow

15 Minute Observation: No Change

45 Minute Observation: Starting to melt in wheel paths

60 Minute Observation: Wheel paths expanding

90 Minute Observation: Bare paths expanding

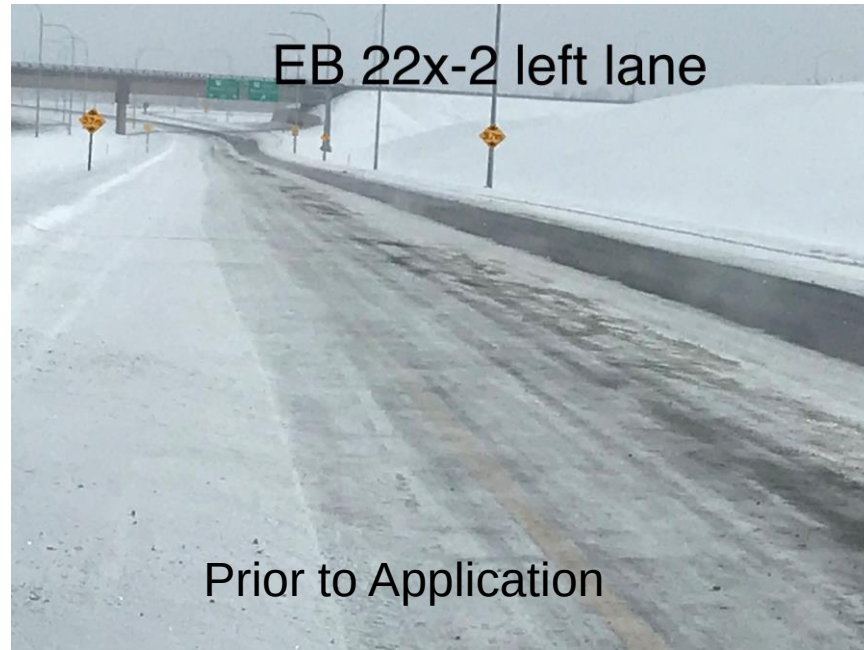
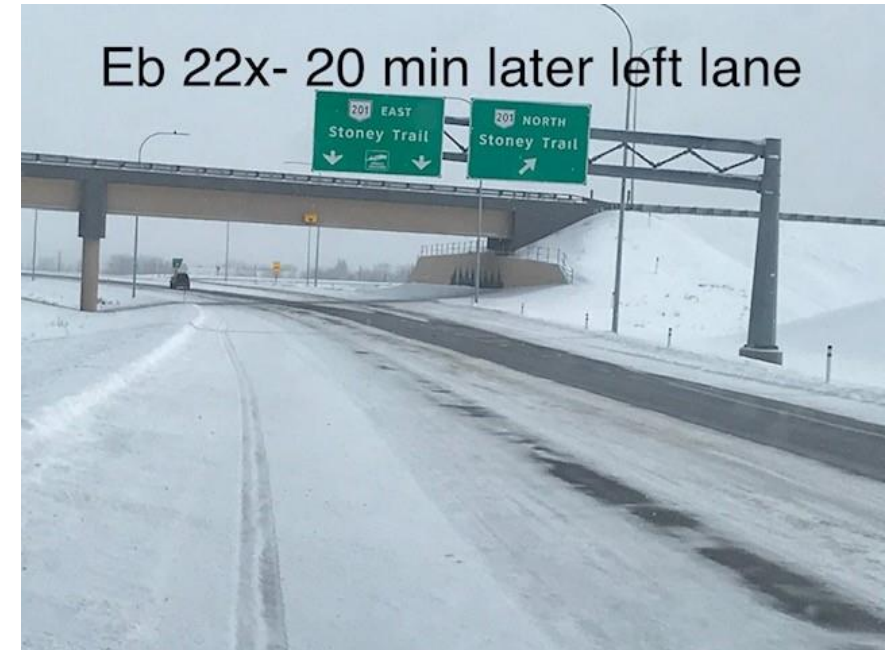
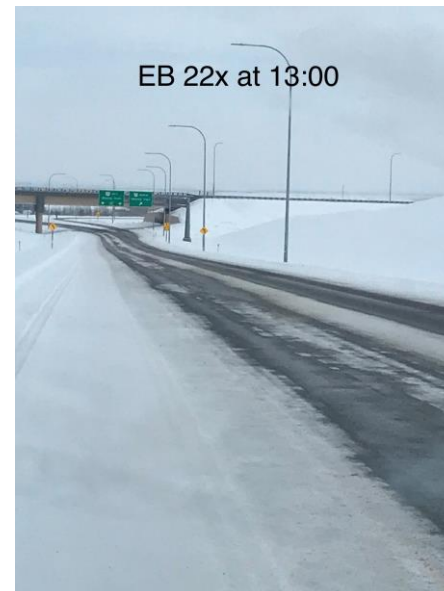
# MARCH 5 SNOW EVENT

Surface Conditions at application: Wet, Snow Covered, Hard Packed

20 Minute Observation: Wheel tracks starting to melt

60 Minute Observation: Wheel paths expanding

120 Minute Observation: Wheel paths bare wet, lanes starting to expand
